8.0 Riley Creek Watershed

Riley Purgatory Bluff Creek Watershed District - 2018 Watershed Management Plan

RILEY CREEK WATERSHED

PROPOSED PROJECTS

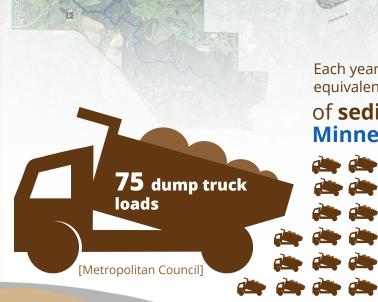
2017 ASSESSMENT RESULTS

Each section of Riley Creek is coded with one of five colors based on how healthy it is. Blue is the best and red the worst.

There is considerable erosion in lower Riley Creek, below Lake Riley, and the creek is listed as impaired for turbidity by the Minnesota Pollution Control Agency. This means it has too much sediment in its water. The district is working with its partners to improve Riley Creek by conducting restoration projects at the sites in most need.

To this end, the watershed district as well as the Metropolitan Council have been monitoring Riley Creek water guality for almost 20 years. Recently, the district developed a new tool to assess the creek: the Creek Restoration Action Strategy (CRAS). The CRAS uses water quality data, as well as information on erosion and habitat to rank which creek sections are doing the best, and which are doing the poorest. Below, the three major types of data used in the assessment are described. On the next page, a creek map shows the results from 2017.
